Little Madawaska Lake Conservation Project

#2003R-35

Waterbody Name: Little Madawaska Lake
Location: Westmanland – Aroostook County
Waterbody Status: Removed from Impaired List
Project Grantee: Town of Westmanland
Project Duration: July 2006 – September 2008
319 Grant Amount: \$79,700
Local Match: \$82,269

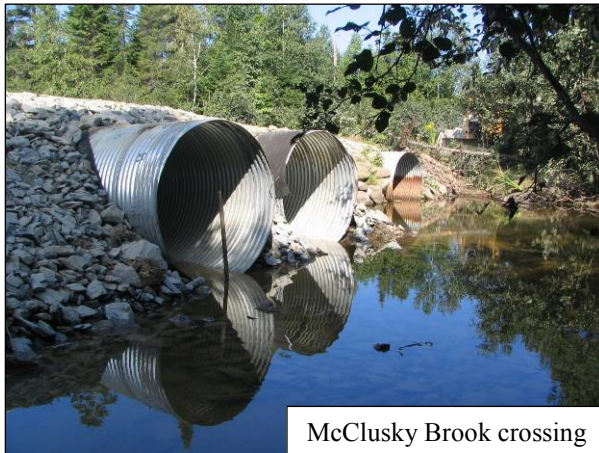
McClusky Brook crossing

- The greatest outcome is the stabilization of major sections of the Little Madawaska Lake Road. The road had been a significant source of sediment load to the lake that contributed an estimated 82.3 tons of sediment/year and 82.3 pounds of phosphorous/year to the lake.
- The correct alignment and sizing of the McClusky Brook crossing prevented a significant washout from occurring during May 2008 County flooding event.
- Sediment and nutrient loading to the lake was reduced by an estimated 83.9 tons of sediment and 83.9 pounds of phosphorous/year (EPA Region 5 Method) The TMDL set a target of 227 pounds of phosphorous from entering the lake; this project met 37% of the target.
- The homeowners and town also put tremendous support behind this project with nearly all the match raised in cash.

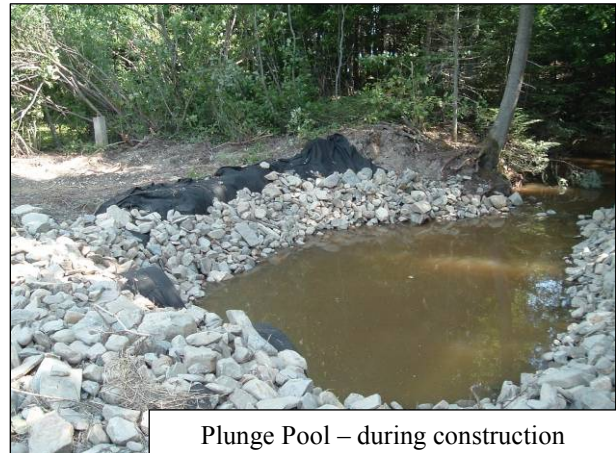
Plunge Pool – during construction

A local contractor who is certified in erosion control practices was hired to install BMPs, which included establishing and/or reshaping ditches, adding appropriate road surface material, grading, installing plunge pools, replacing culverts and reconstructing a stream crossing on LMLR. Residential BMPs included redirecting water from driveways into stable areas, planting buffers, limited use of rip rap, controlling roof runoff, and using reverse drainage swales.
