Panther Pond Conservation Project – Phase I

#2005R-17

Waterbody Name: Panther Pond
Location: Raymond, Casco – Cumberland County
Waterbody Status: NPS Priority Watershed, Most at Risk
Project Sponsor: Town of Raymond
Project Duration: April 2005 – August 2008
319 Grant Amount: \$43,945
Local Match: \$144,699

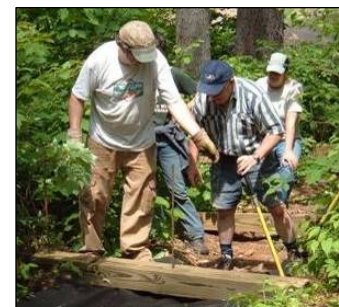
Volunteers build infiltration steps and spread mulch on an eroded path to the lake.

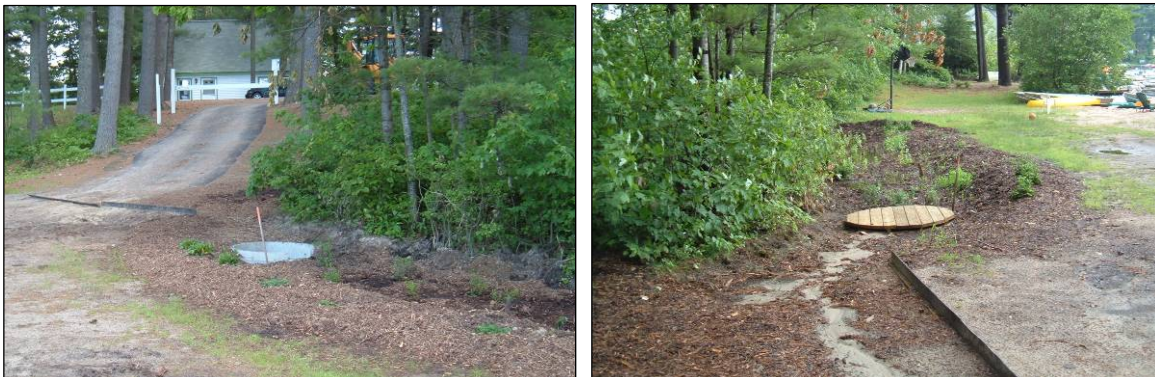
Prior to construction, runoff raced down the paved boat launch and created large gullies in the beach. With project cost sharing, the landowner installed a rubber blade at the base of the pavement to divert water into a new rain garden. A sediment ring catches sediment before it reaches the garden.
