# McLean Brook Watershed BMP Implementation Project

## 2010RR03

Waterbody Name: McLean Brook

Project Grantee: St. John Valley SWCD

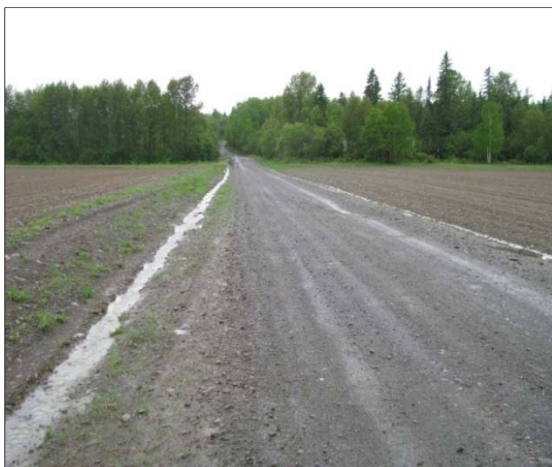
Town road lacking a stabilized ditch

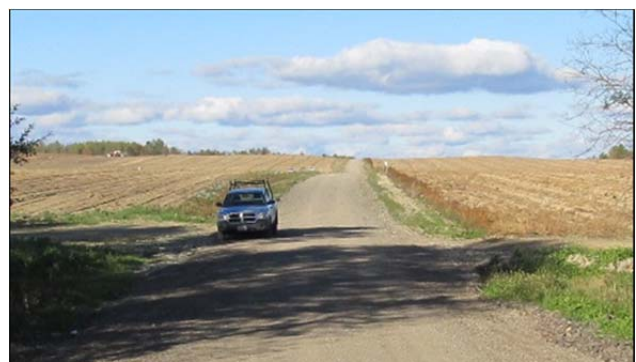
Town road with a grass-stabilized ditch
