Maranacook Lake-North Basin Watershed Survey & Demonstration Project

#98-18

Waterbody Name: Maranacook Lake - North Basin
Location: Readfield - Kennebec County
Waterbody Status: NPS Priority Watersheds, Most At Risk
Project Grantee: Town of Readfield
Project Duration: March 2000 – January 2004
319 Grant Amount: \$12,750
Local Match: \$11,678

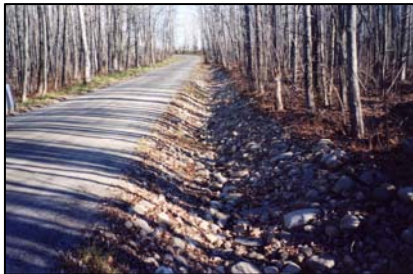
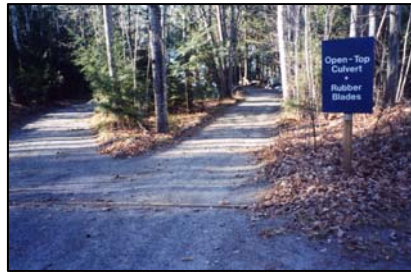
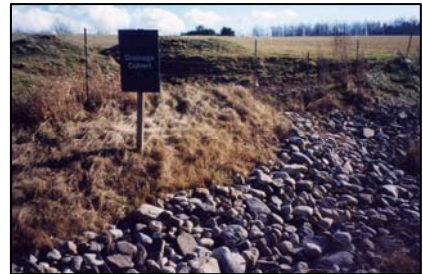
- 108 erosion sites and 980 feet of eroded shoreline were identified in the watershed and shoreline survey. A watershed survey report was completed- “Maranacook Lake-North Basin Camp Road & Shoreline Erosion Survey Summary Results”, August 2001.
- Camp road and driveway demonstration projects were installed on Thorpe Shores Road and included the following:

Road re-shaped	Rubber razor blades (2)
Culvert replacement (2)	Open-top box culverts (3)
Culvert armoring and plunge pools (2)	Vegetated buffer
Ditch re-shaped (2000’)	Waterbars (7)
Ditch armored (1000’)	Project and BMP identification signs
Ditch turn-outs (4)	
- The demonstration work spurred additional conservation practice installation. The Thorpe Shores Road Association took initiative to raise funds for remediation on the remaining segment of road not included in the demonstration project. Other road associations have installed conservation practices with assistance from Kennebec County SWCD.
- Cobbossee Watershed District obtained EPA 319 funding in 2004 to survey the southern basin and develop a management plan for the entire Maranacook watershed.
