## Norway Lakes Improvement Project, Phase III

#2002-08

## Erosion Control and Paved Shoulder Enhance 118

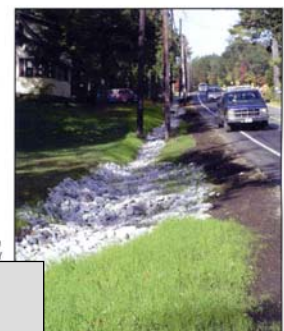
BEFORE

**Project Description:**  
The Norway Route 118 project was nominated by Rick Jeselskis of the Western Region MaineDOT in the fall of 2003. The project site consisted of approximately 1500' of roadway south of Hobbs (Little Pennessewassee) Pond. The road section contributes runoff to an unnamed tributary stream which enters the Hobbs Pond. The primary concern on site was moderate erosion along the road shoulders, ditch erosion, and failing driveway culverts due to unstable shoulder erosion.

**Best Management Practices Design:**  
The BMP design for this section of road included stone-lined and erosion control blanket-lined ditches. Additionally, a sediment trap and an armored filter berm were constructed on the lower end of the ditchline. A straw erosion control blanket was used on sensitive backslopes, in the ditch bottom of the upper ditch to prevent post-construction scour, and to provide stability for vegetative reestablishment. The filter berm was constructed of erosion control mulch and crushed stone for low flow filtration, and a riprap overflow weir for high flows. Erosion control mulch and seed mix was applied through a blower truck on the inslopes of the project area. Improvement of the turnout and paved shoulders should eliminate shoulder erosion on the site.
